FIRE RISK ASSESSMENT

Sample Fire Risk Assessment 51, Riverside View, Exeter, Devon, EX1 2BD

VALID BETWEEN	10/05/2000 - N/A
ASSESSED BY	Max Dolby Ryan Beard
ASSESSED ON	10/05/2000
ASSESSMENT REF.	RB-H55CGI
VERSION	1

ASSESSMENT SCOPE
carry out type one fire risk assessment covering the building upstairs common areas, and outside public areas and car park.

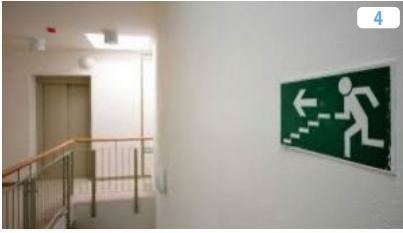
Escape routes and fire exits are clearly signposted.

Instructions in the case of fire are clearly displayed.

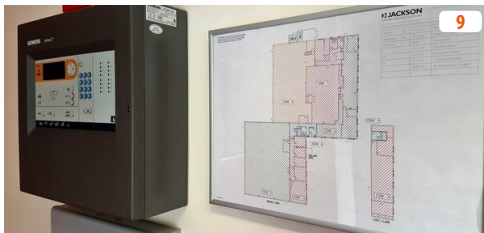
LD1 alarm systems are installed throughout the premises

Category LD1 – Maximum life protection LD1 alarm systems are installed throughout the premises. Detectors are fitted in all areas that form escape routes and in all rooms and other areas, other than those that have a low risk of ignition, such as bathrooms and toilets.
